## PART 3

## CONVERTER AND TRANSMISSION ALIGNMENT

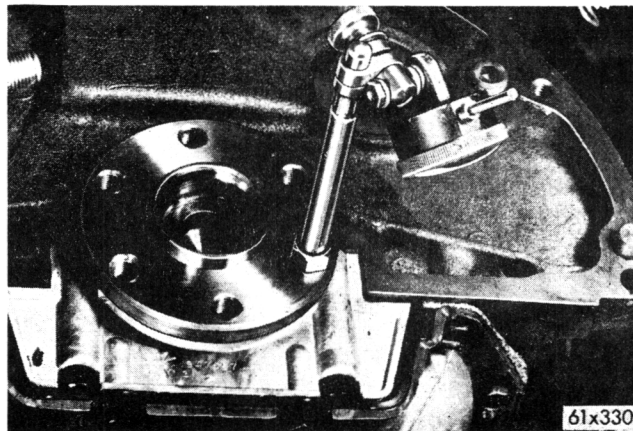
- (11) Install dial indicator on crankshaft flange (see Fig. 1). An indicator post can be made by cutting a 7/16"-20 T.P.I. thread on end of a rod approximately 5½" long.

Fig. 1 – Dial indicator installation

(13) Position dial indicator plunger to the engine transmission mounting face and rotate the engine crankshaft to read any runout. (Runout should not exceed .010 inch T.L.R.).

(2) Attach dial indicator to engine block flange (*see Fig. 1*). Position dial indicator so dial plunger rests on converter hub (just ahead of pump drive slots).

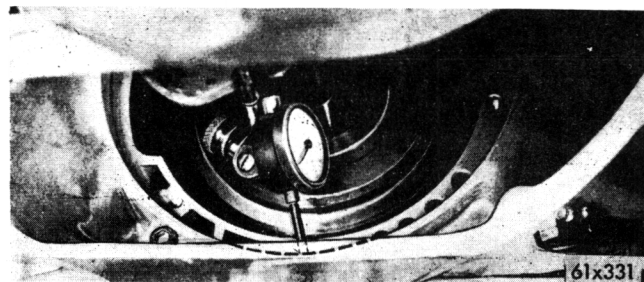
(15) Position dial plunger against bore diameter which pilots front pump assembly (see Fig. 2). Make sure plunger does not rest on chamfered edge of bore. To adjust dial and plunger, reach into case from front, below engine oil pan. Adjust dial and plunger to that plunger can travel in each direction.

Fig. 2 – Checking transmission case (front pump bore) runout

(17) Measure bore runout by rotating crankshaft slowly, recording the readings every 45° of rotation. Also record the points of maximum and minimum readings. Use a mirror if necessary to see the dial as it is being rotated. Total runout of bore should not exceed .015".

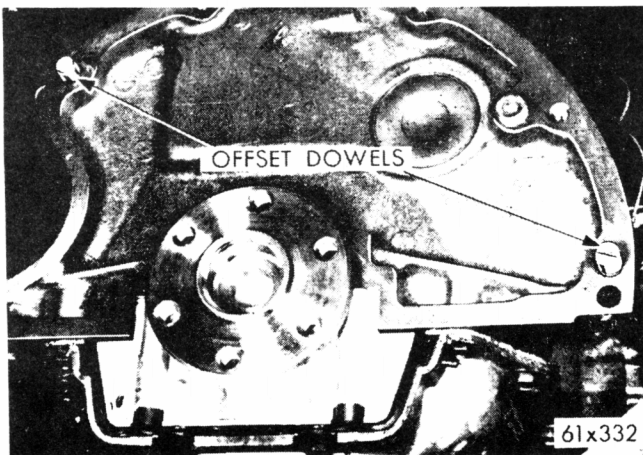
(2) Drive old dowels from engine block flange and install the selected offset dowels with slots parallel and offset in the direction of runout. The upper dowel must be installed with the slotted end into block flange (toward the front of engine). Install lower dowel with slotted end toward rear, as shown in *Fig. 3*. Both dowels must be installed up the shoulder of offset.

Fig. 3 – Offset dowel installation

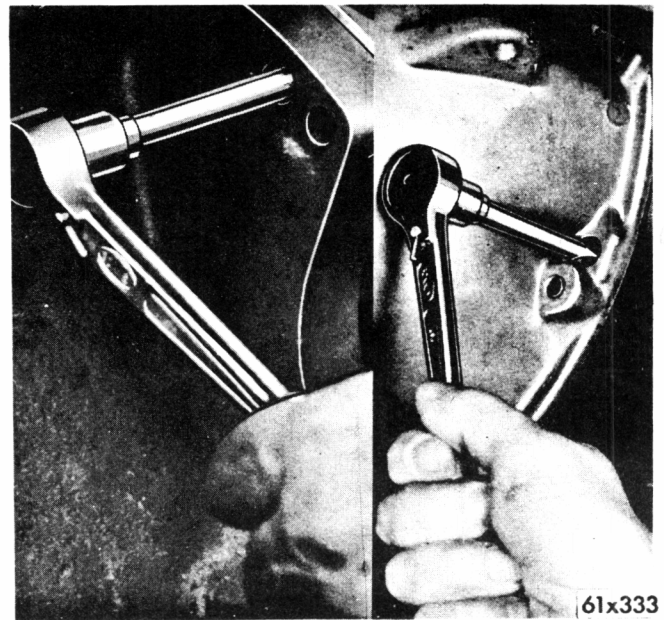
(4) Small corrections can be made by turning dowels with a screwdriver bit and wrench (*see Fig. 4*), support weight of transmission and loosen case

bolts slightly. Turn dowels to obtain as near zero runout as possible. The dowel slots must be kept approximately parallel to maintain correct centre distance between dowels.

Fig. 4 – Adjusting offset dowels

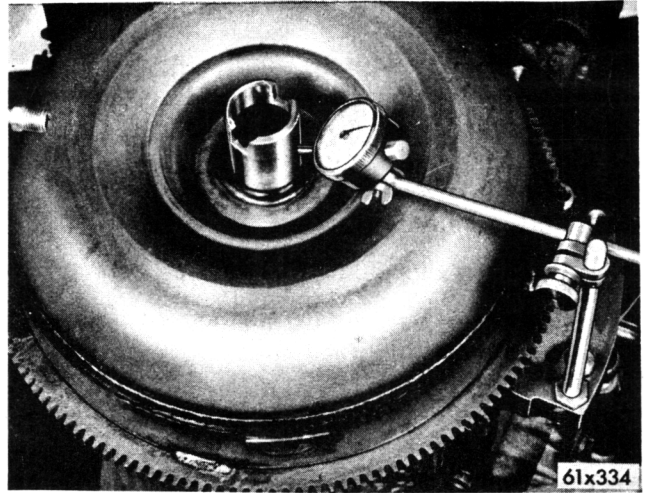
(3) Rotate crankshaft with a wrench on bolt at front end of crankshaft, and check converter hub runout. Do not rotate converter by hand or with a

(4) The total runout of converter hub should not exceed .015". Runout less than .050" may be corrected by the use of a large C clamp. Attach clamp in front of engine block flange and behind starter ring gear on converter. Draw ring gear adjacent to the low runout point of converter hub toward engine.

Fig. 5 – Checking converter hub runout
