INTAKE MANIFOLD SEALING

Intake manifold sealing to the heads can be a major tuning problem and is fairly common. Many times, it is misdiagnosed as bad valve stem seals because oil puddles up behind the intake valves. About 75% of the engines we build need the intake manifold corrected. This is how we do it.

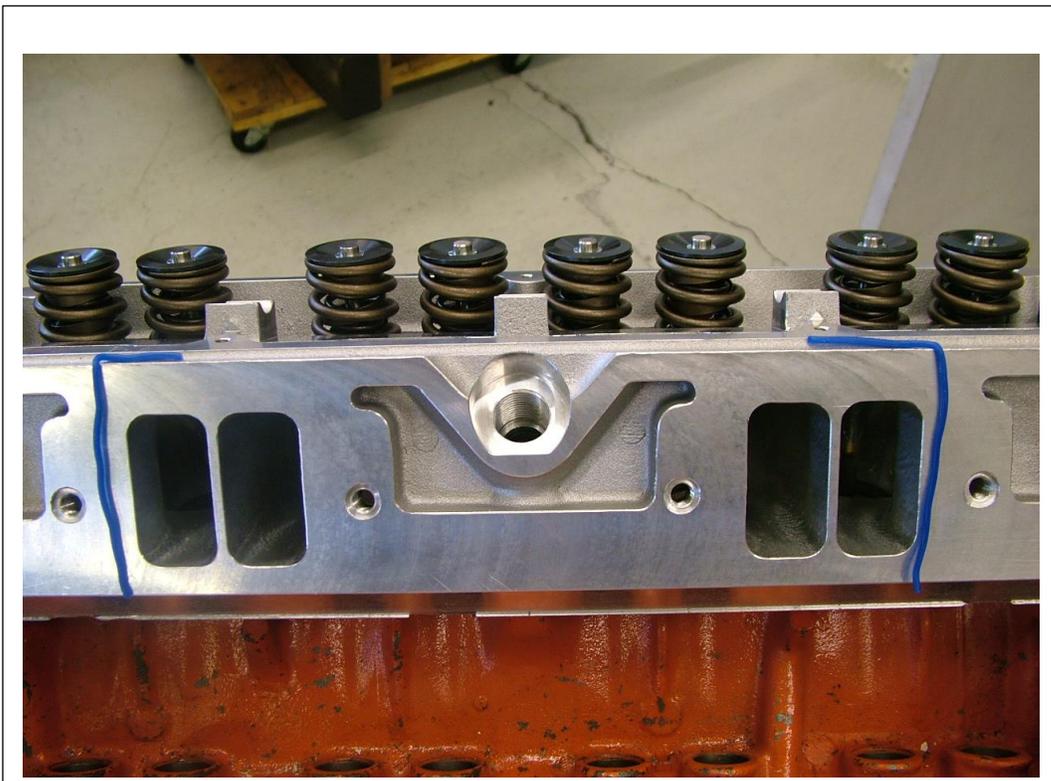
Use a piece of 10 gauge (.100") wax wire* along the outer side of the 2 end ports on each head and hook it over the top of the head as shown in the photo below.

Note: If you lightly apply WD-40 to the area where the wax wire lays, it will make disassembly easier.

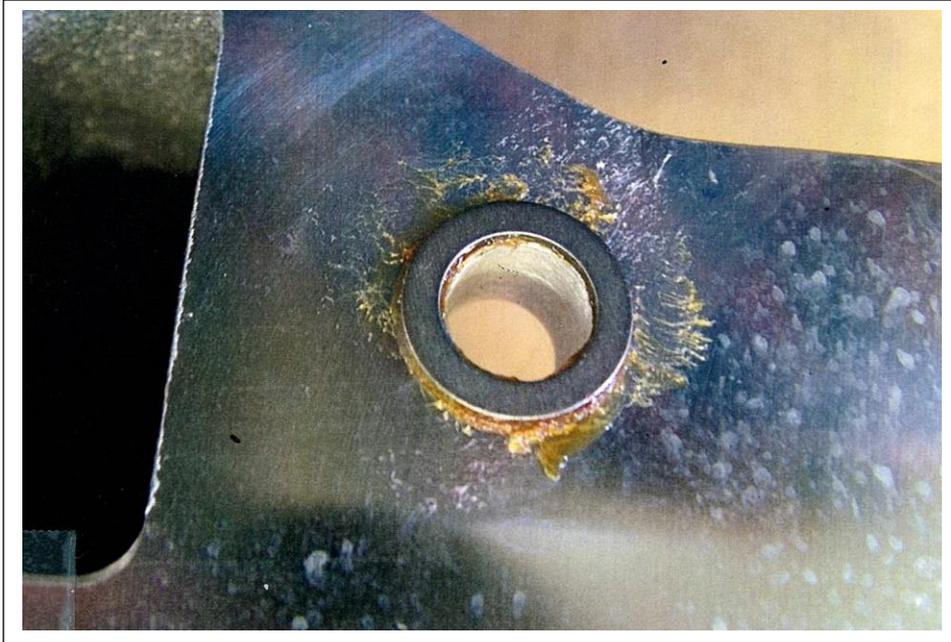
Now use some sticky grease to “glue” 4 washers to the manifold around the bolt holes next to the wax wire (as shown in photo below). The washers must be the same thickness at all four corners, unless you are working on a CHIVVY, then it does not make any difference.

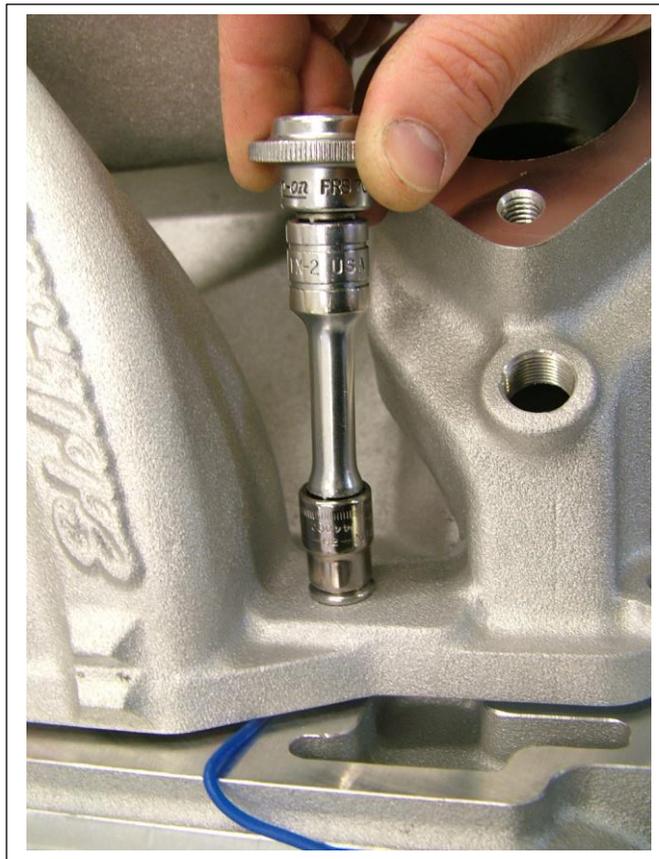
Place the manifold gently, so as to not displace (that means move out of place for you Ford guys) the washers or the wax wire onto the heads. Install and snug the bolts down to bottom the manifold against the washers. Lightly hand torquing with a spinner as shown below is plenty. You will actually feel the wax wire compress, how sweet it is!

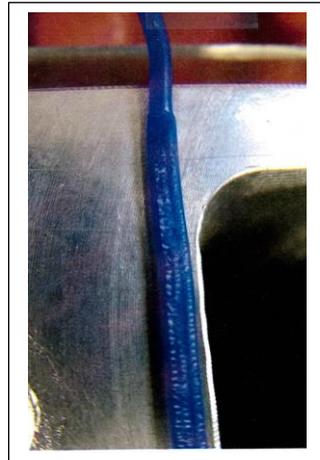
The photo below shows what the flattened wax wire should look like.

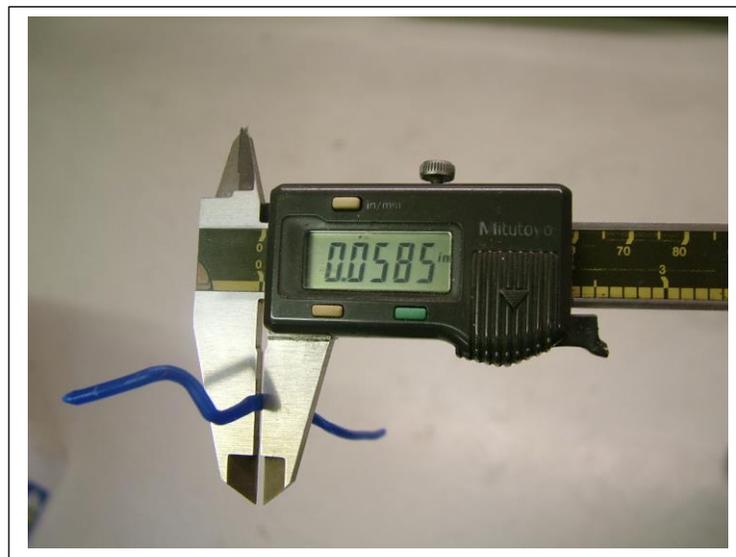
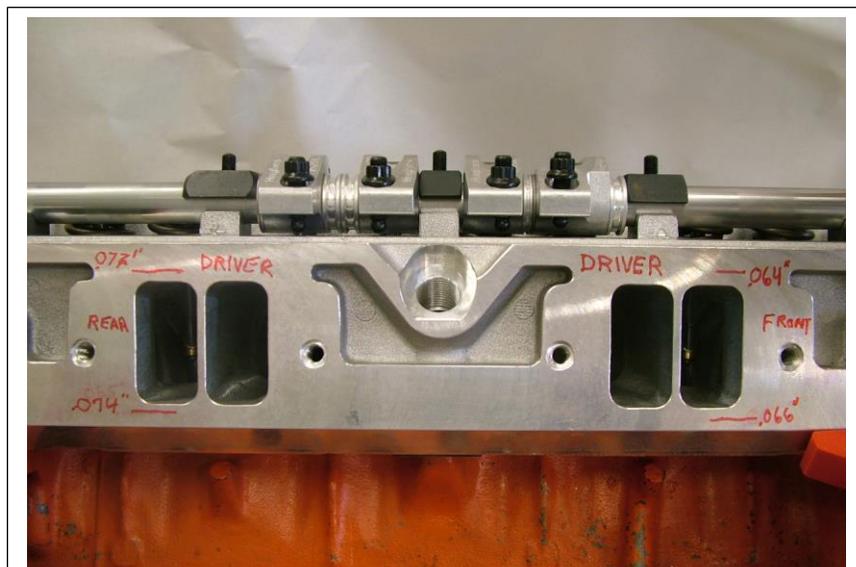
Now carefully measure the thickness of the wax wire using a dial caliper, as it was not as easy to crush the wax as it is with a micrometer. And, you don't want to crush the wax Bubba, or your manifold will still leak. Measure in the flattened area at the top and bottom of the wax wired and write these numbers on the intake gasket surface of the heads as shown in the 2nd & 3rd photos below.

The red line in the previous photo indicates what the wax wire measured at that point on the driver's side, measure and mark both sides.

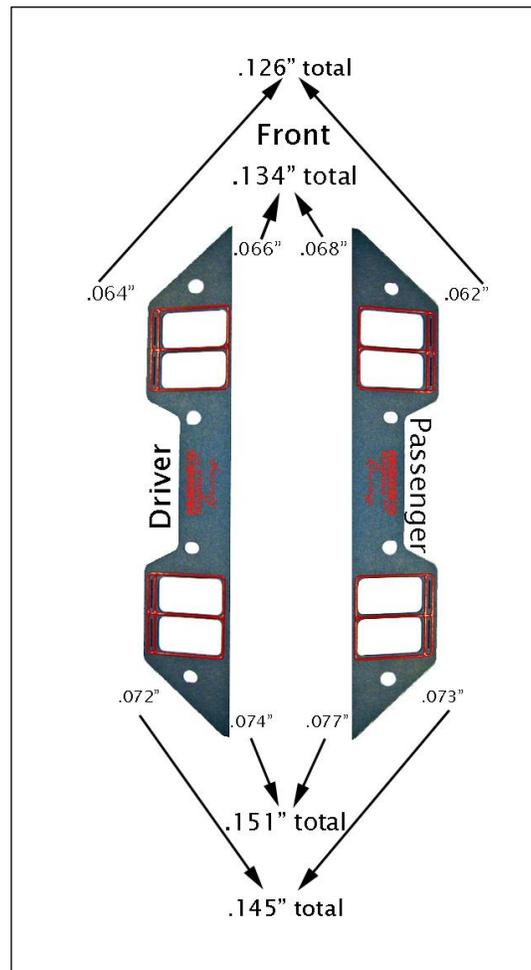
In the example shown below, the total gap (both sides) at the top front is $.062" + .064" = .126"$. At the bottom it is $.066" + .068" = .134"$. This indicates the front of the manifold has a .008" larger gap at the bottom than at the top.

The total gap at the rear on top is $.072" + .073" = .145"$. At the bottom it is $.074" + .077" = .151"$

The example shown above indicates that our front has a .008" larger gap at the bottom, the exact opposite of what we want. The rear has a .006" larger gap, also at the bottom.

Also note that the gaps are greater at the rear. The difference of the gaps, in this case about .018" ($.151" - .134" = .017"$ and $.145" - .126" = .019"$). This means that a total out of .019" more on the front of the manifold will equalize the inequity in front to rear gaps.

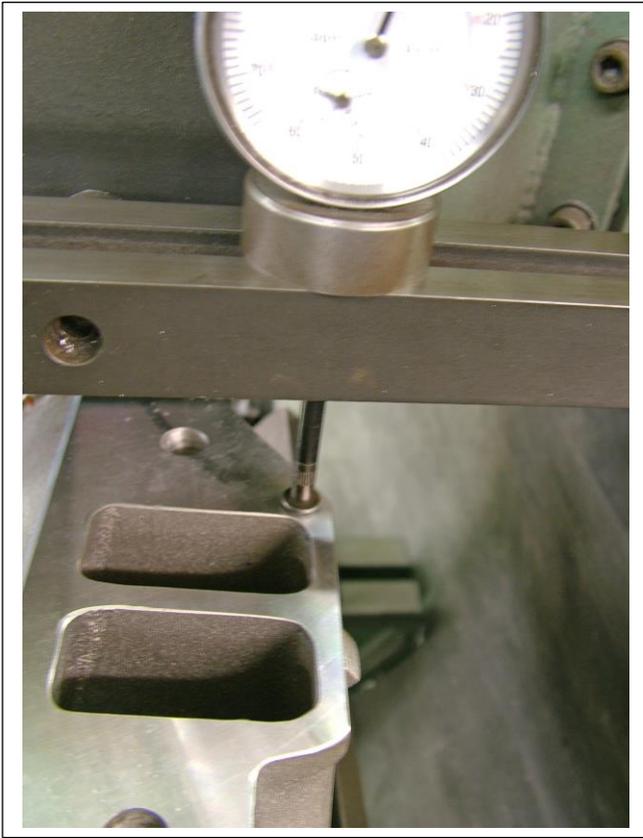
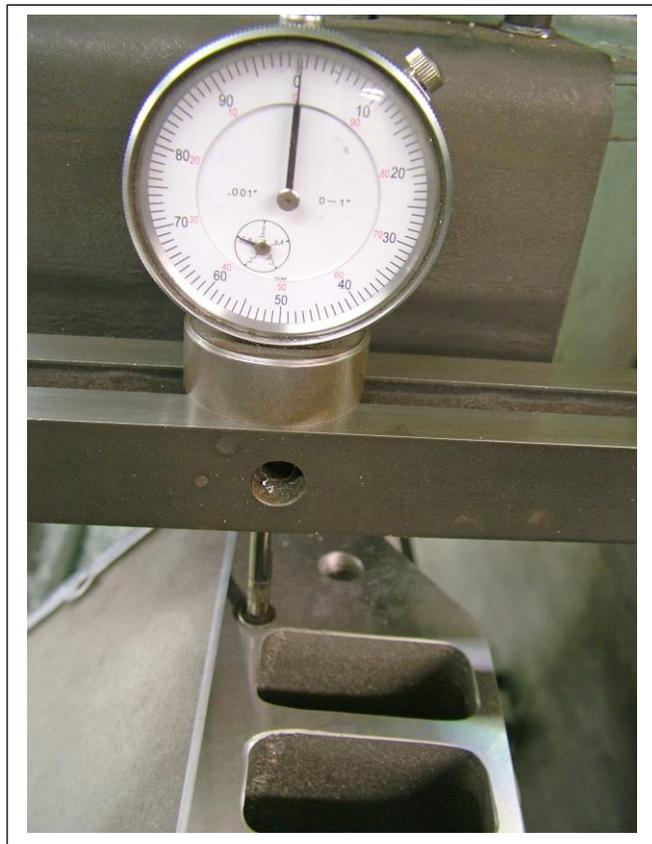
As you can see in the photos below, when setting up the manifold to mill, we check in the same places the checking wax wire was located.
